RENOVATION OF THE ROOF TERRACE PLAZA AT THE KENNEDY CENTER FOR THE PERFORMING ARTS

E. GERNS¹, H. HUNDERMAN²

Wiss, Janney, Elstner Associates, Chicago and Northbrook, Illinois, USA

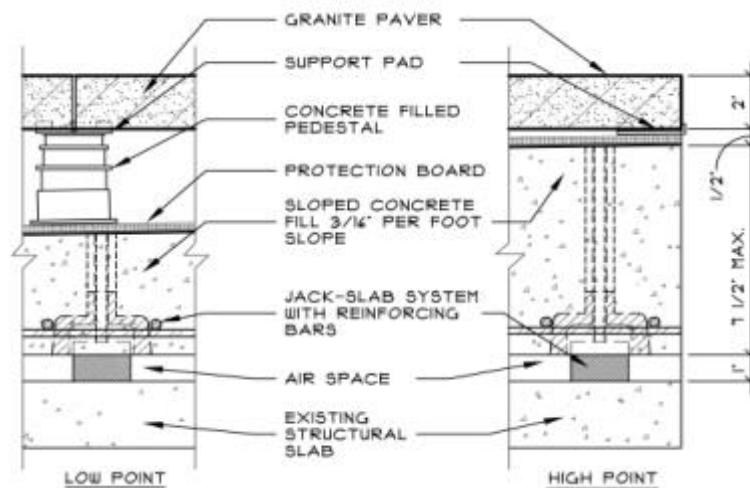
Figure 2: Representative sections of the replacement plaza system

The pavers were installed on high-density rubber pads set on concrete filled adjustable plastic pedestals that were centered at each crossing joint. The rubber pads incorporated 1/8 inch (3.2mm) wide separation tabs to maintain a consistent joint width and prevent adjacent pavers from shifting into each other. A very narrow joint was necessary so high heels would not catch in the joints. Joint tolerances were specified to limit the maximum allowable joint width to 3/16 inch (4.8 mm).

The pedestal system was placed on a hot applied rubberized asphalt waterproofing system installed on a cast-in-place concrete acoustical isolation and drainage slab. Acoustical isolation was accomplished by incorporating a 1 inch (25 mm) air cavity between the original structural slab and the new acoustical-drainage slab. Two options existed for creating this space. One option consisted of a system of rubber "pucks" with formwork set on the pucks and a concrete isolation slab cast on the formwork. The other option is a jack-slab system. The jack slab is a concrete slab with embedded steel castors that is cast on a slip-sheet over the structural slab. The castors consist of a rubber puck fit into a steel casting. Seats for reinforcing steel are located around the perimeter of the casting at quarter points. The concrete slab is cast and
